Certificate of Substantial Completion

PROJECT: *(name and address)*
New Pool at Zemurray Park
Hammond, LA

CITY OF HAMMOND
ZEMURRAY PARK POOL
 September 11, 2019
 GGB Project 1624

Mechanical Punchlist Report

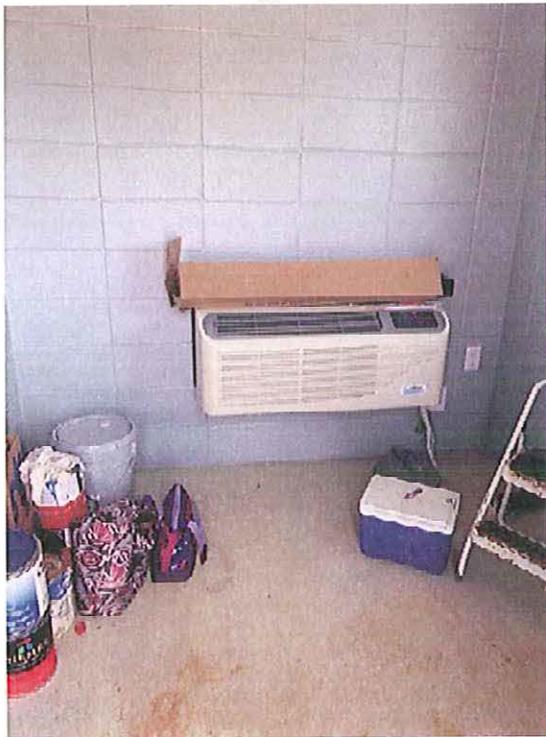
5.

| | <ul style="list-style-type: none"> • \$1,000 • \$2,000 • \$500 • \$200 • \$200 | <ul style="list-style-type: none"> • PTAC-1 located in Office room 11 not operating at time of inspection. See picture #5. • Route drainage piping from reduced pressure back flow preventer located in Equipment room 12 thru block wall, down to sump pit at bottom of pool pit. Seal piping penetration thru block wall. • Provide supports for back flow preventer located in Equipment room 12. Current supports not acceptable. • Provide caulking around base of all plumbing fixtures throughout project. • Clean dirt/debris & protective taping off of all floor drain strainers throughout project. |

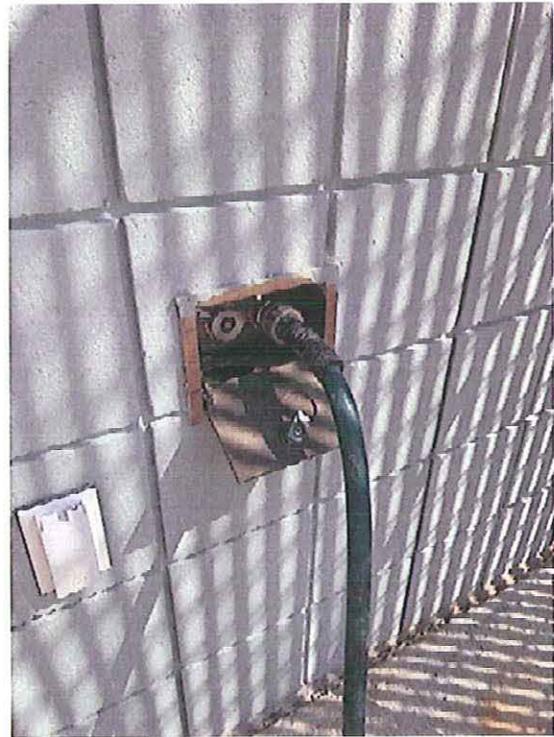
| Deficient Items: Total \$22,000 | <ul style="list-style-type: none"> • \$1,000 • \$500 • \$300 • \$1,500 • \$800 • \$1,500 • \$4,000 • \$100 • \$1,200 • \$3,000 • \$100 • \$500 • \$1,500 • \$500 • \$900 • \$500 • \$200 | <ul style="list-style-type: none"> • Patch exposed holes in block wall around shower units, multiple locations. See picture #1. • Provide insulation, piping labels, & directional arrows on all domestic water piping located in Water Heater room 18. See pictures #3, & #4. • Provide supports for thermal expansion tank. Current supporting not acceptable. See pictures #3, & #4. • Electric water heater (WH-1) not operational at time of inspection. • Instantaneous water heater (WH-2) to serve Lavatory located in Equipment room 12 not operational at time of inspection. • Instantaneous water heater (WH-2) not installed within shroud located under wall mounted lavatory as indicated on drawings. See picture #7. • Sanitary vent piping stubbed out in room at time of inspection, typical of 4 locations. Contractor to extend vent piping up through roof in Changing rooms 1, 8, 10, & Equipment room 12. See pictures #11, #16, #20, & #21. • Clean paint and debris off of all hose bibbs throughout project. See picture #6. • Electric water cooler located on exterior of building installed over hose bibb at time of inspection. Fixture to be installed not to conflict with use of hose bibb. See picture #14. • Sump pump located in pit of Equipment room 12 not installed at time of inspection. See picture #10. • Drain located at base of emergency shower/eyewash station in equipment room 12 currently installed facing wall. Drain to be installed to face floor drain. See picture #8. • Provide hub/funnel on storm drain piping stub-up in Equipment room 12 to prevent backsplash as indicated on pool equipment drawings. See picture #9. • Complete installation of exhaust fan 13 located in Chemical room 13. See picture #12. • Complete insulating exposed domestic water piping within Changing rooms. See pictures #16, & #21. • Contractor to provide and install smooth surface aluminum jacketing on exposed domestic water piping routed over Check-in canopy. Jacketing to be painted to match adjacent tin roof/walls. See picture #13. • Contractor to seal around all brick vents throughout project and provide insect screens as specified on Mechanical drawings. See picture #2. • Contractor to seal around thru-the-wall heat pump unit (PTAC-1) located in Office room 11. See pictures #5, #18, & #19. |

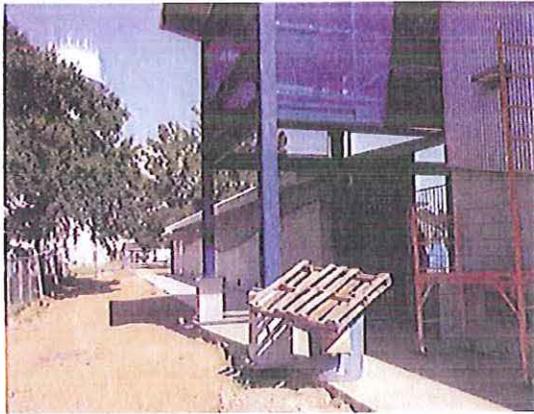
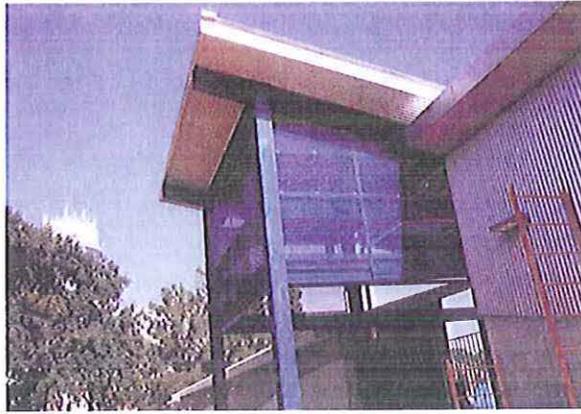
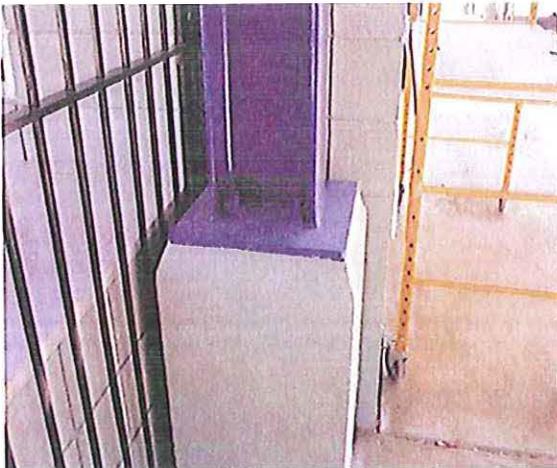
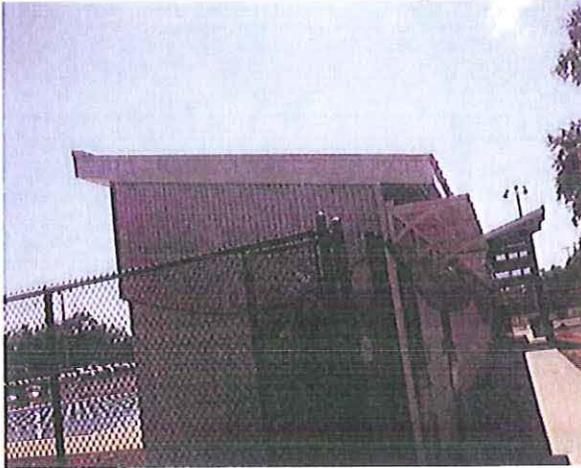
1. Foundations, building masonry, steel framing and roof framing all appear to be complete. See pictures below for reference.
